NASA/TP-97-206257

The Characteristics of Fatigue Damage in the Fuselage Riveted Lap Splice Joint

Robert S. Piascik
Langley Research Center, Hampton, Virginia

November 1997

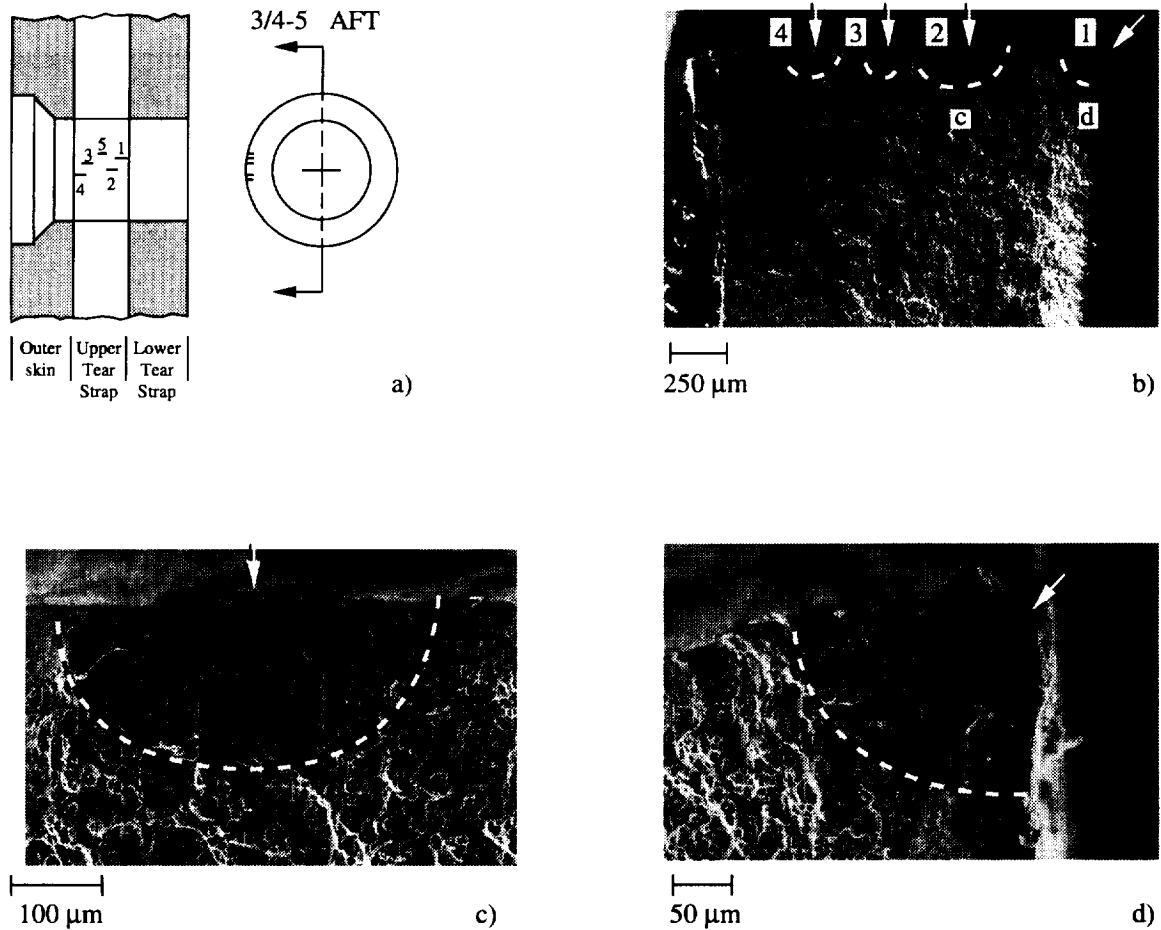
Figure 10.15 a) The schematic shows the rivet hole 3/4-5 configuration and the location of five upper T.S. fatigue cracks oriented in the aft direction and about the 9 o'clock position. b) The SEM micrograph shows the location of four fatigue cracks at the upper tear strap rivet hole (top). Cracks #2, #3, and #4 are rivet hole surface cracks and crack #1 is located on the inboard corner. The dashed line marks the fatigue crack fronts. The arrows mark the likely sites of crack initiation. c) The SEM micrograph shows the fatigue fracture surface of fatigue crack #2 at region "c" in Figure 10.15.b. The arrow marks the area of crack initiation and the dashed line marks the fatigue crack front. d) The SEM micrograph shows the inboard corner crack, region "d" in Figure 10.15.b, at higher magnification. The arrow marks the crack initiation site and the dashed line marks the fatigue crack front.

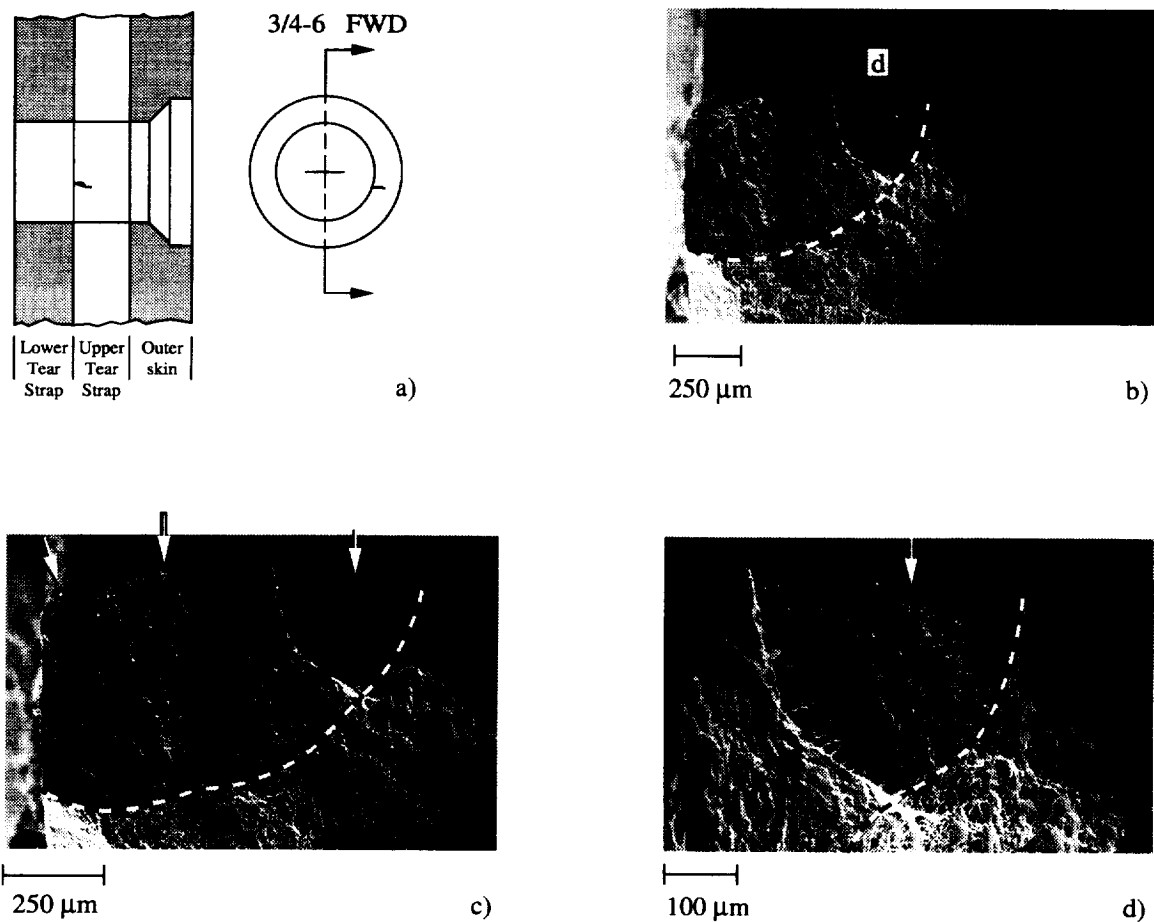
Figure 10.16 a) The schematic shows the rivet hole 3/4-6 configuration and the location of an upper T.S. fatigue crack oriented in the forward direction and about the 4 o'clock position. b) The SEM micrograph shows the fatigue crack located on the inboard corner of the upper T.S. rivet hole. The dashed line marks the fatigue crack front. c) The SEM micrograph shows three possible sites (arrows) where fatigue cracks initiated and subsequently coalesced into a corner crack marked by the dashed line. Two fracture surface ridges mark the location where the small fatigue cracks joined to form a single corner crack. d) The SEM micrograph shows region "d" in Figure 10.16.b at high magnification. The arrow marks the approximate site of crack initiation and the dashed line marks a portion of the fatigue crack front. A ridge created by cracks that coalesced runs from the upper left to the lower middle of the micrograph.

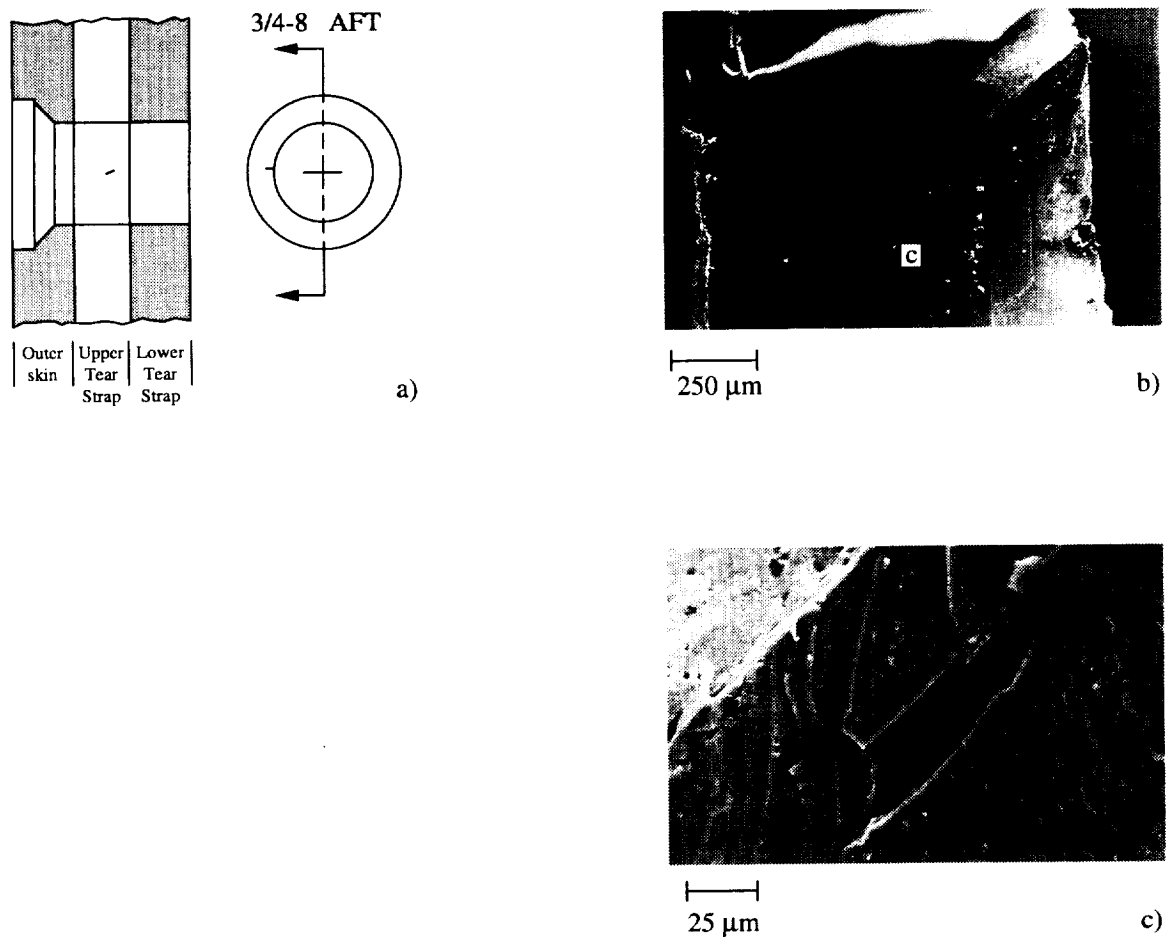
Figure 10.17 a) The schematic shows the rivet hole 3/4-8 configuration and the location of an upper T.S. fatigue crack oriented in the aft direction and about the 9 o'clock position. b) The SEM micrograph shows the inside surface of the upper T.S. rivet hole and the location of a small fatigue crack barely visible at the region marked "c". The main fracture surface produced during the destructive examination is located just above region "c". c) The SEM micrograph shows the partially opened surface fatigue crack located at region "c" in Figure 10.17.b. The crack mouth was opened during the destructive examination. SEM examination into the crack mouth confirmed transgranular fatigue crack growth.

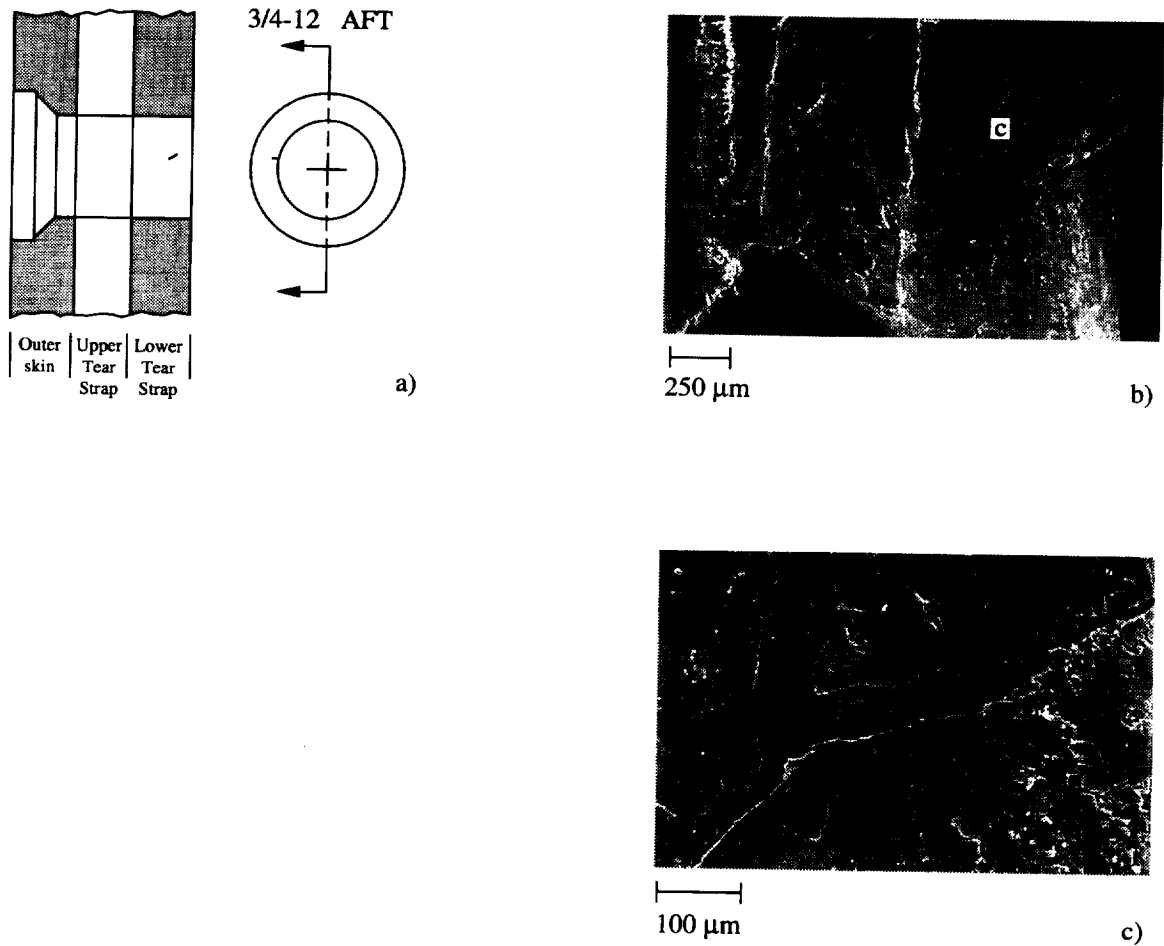
Figure 10.18 a) The schematic shows the rivet hole 3/4-12 configuration and the location of an upper T.S. fatigue crack oriented in the aft direction and about the 9 o'clock position. b) The SEM micrograph shows the inside surface of the upper T.S. rivet hole and the location of a fatigue crack at region "c". The main fracture surface produced during the destructive examination is partially visible at the bottom of the micrograph. c) The SEM micrograph shows the partially opened surface fatigue crack located at region "c" in Figure 10.18.b. The crack mouth was opened during the destructive examination. SEM examination into the crack mouth confirmed transgranular fatigue crack growth.

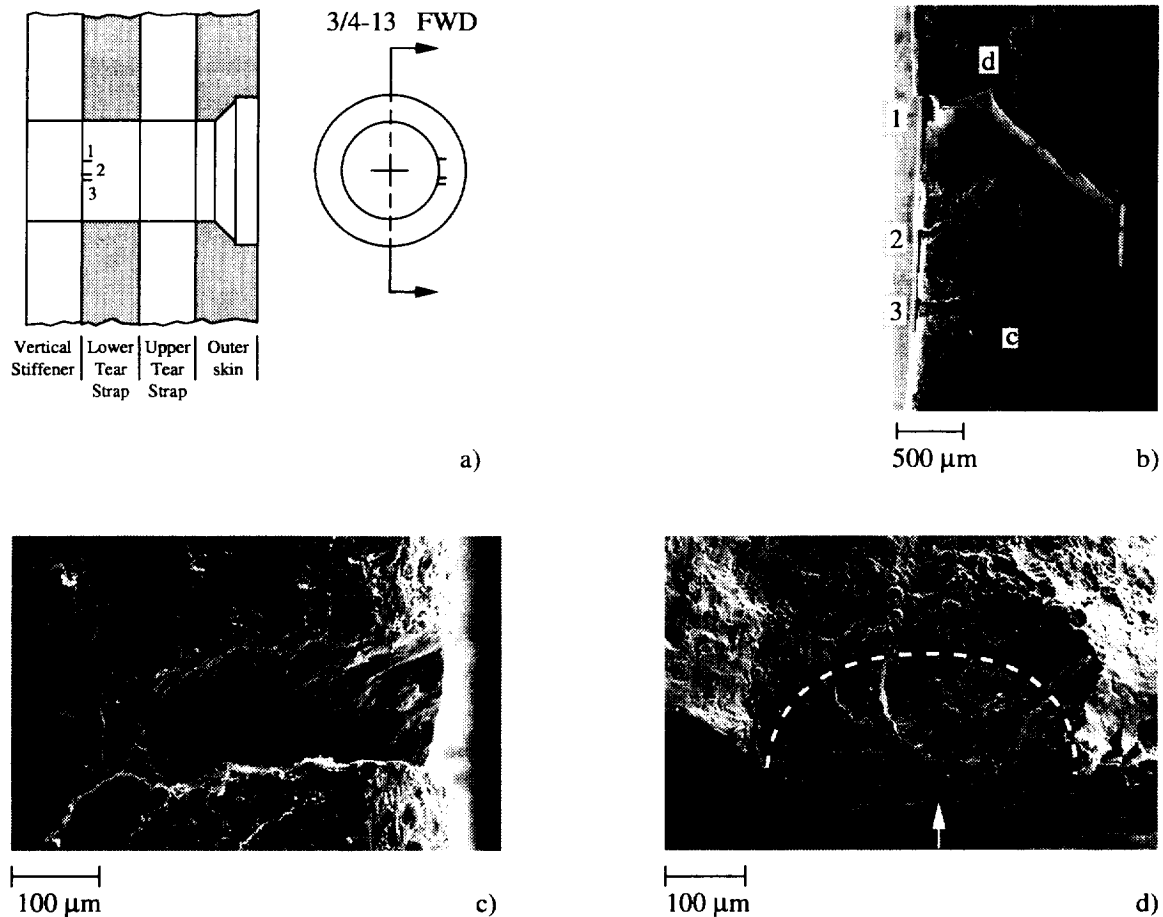
Figure 10.19 a) The schematic shows the rivet hole 3/4-8 configuration and the location of three lower T.S. fatigue cracks oriented in the forward direction and about the 3 o'clock position. b) The SEM micrograph shows the inside surface of the lower T.S. rivet hole and the location of the three small cracks along the inboard corner of the rivet hole. Crack #1 is located on the main fracture surface and cracks #2 and #3 are partially opened. c) The SEM micrograph shows the partially opened rivet hole corner fatigue crack #3 located at region "c" in Figure 10.19.b. The crack mouth was opened during the destructive examination. d) The SEM micrograph shows the surface fatigue crack #1 located near the inboard corner at region "d" in Figure 10.19.b.

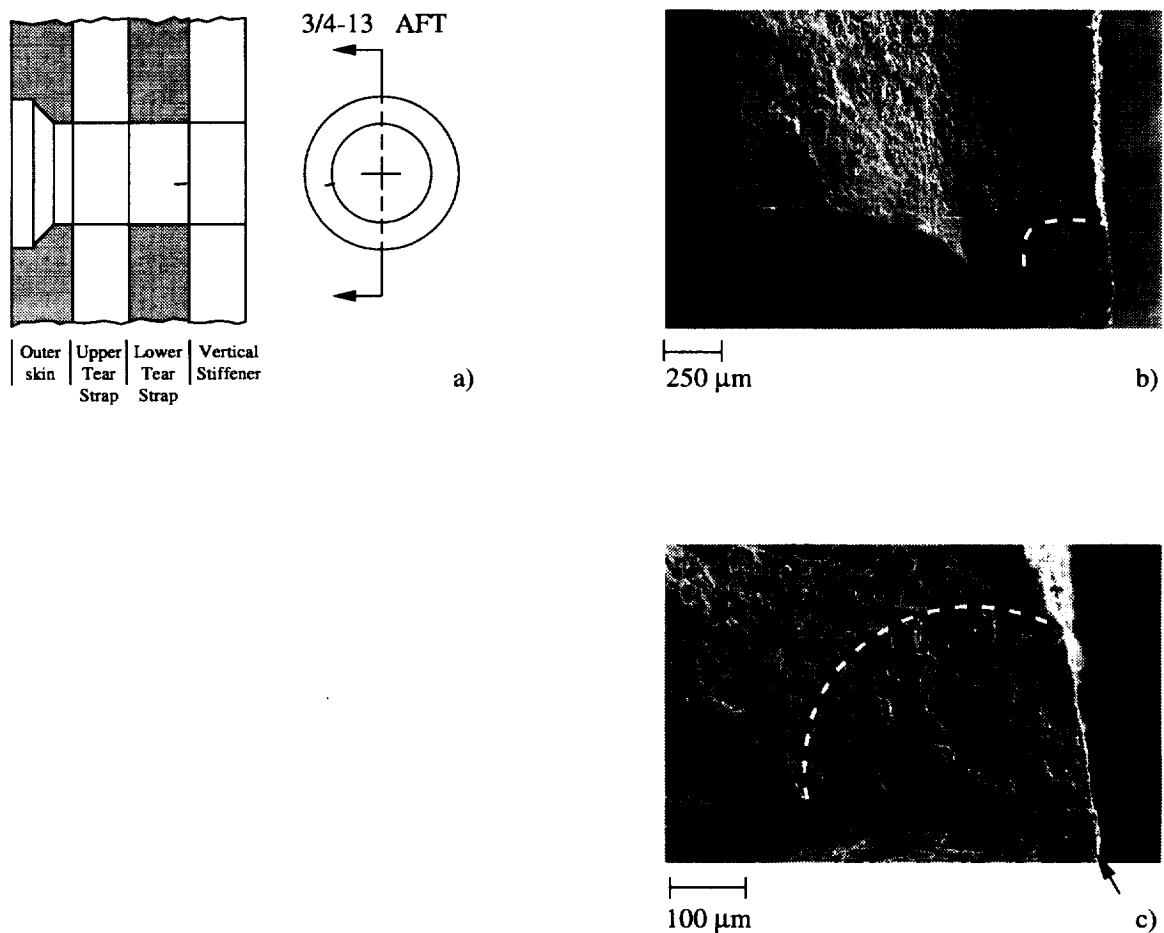
Figure 10.20 a) The schematic shows the rivet hole 3/4-13 configuration and the location of a lower T.S. fatigue crack oriented in the aft direction and below the 9 o'clock position. b) The SEM micrograph shows the fatigue fracture surface of the corner crack located on the inboard corner of the rivet hole. The dashed line marks the fatigue crack front. c) The SEM micrograph shows the fatigue fracture surface of the corner crack. The arrow marks the likely site of crack initiation and the dashed line marks the fatigue crack front.

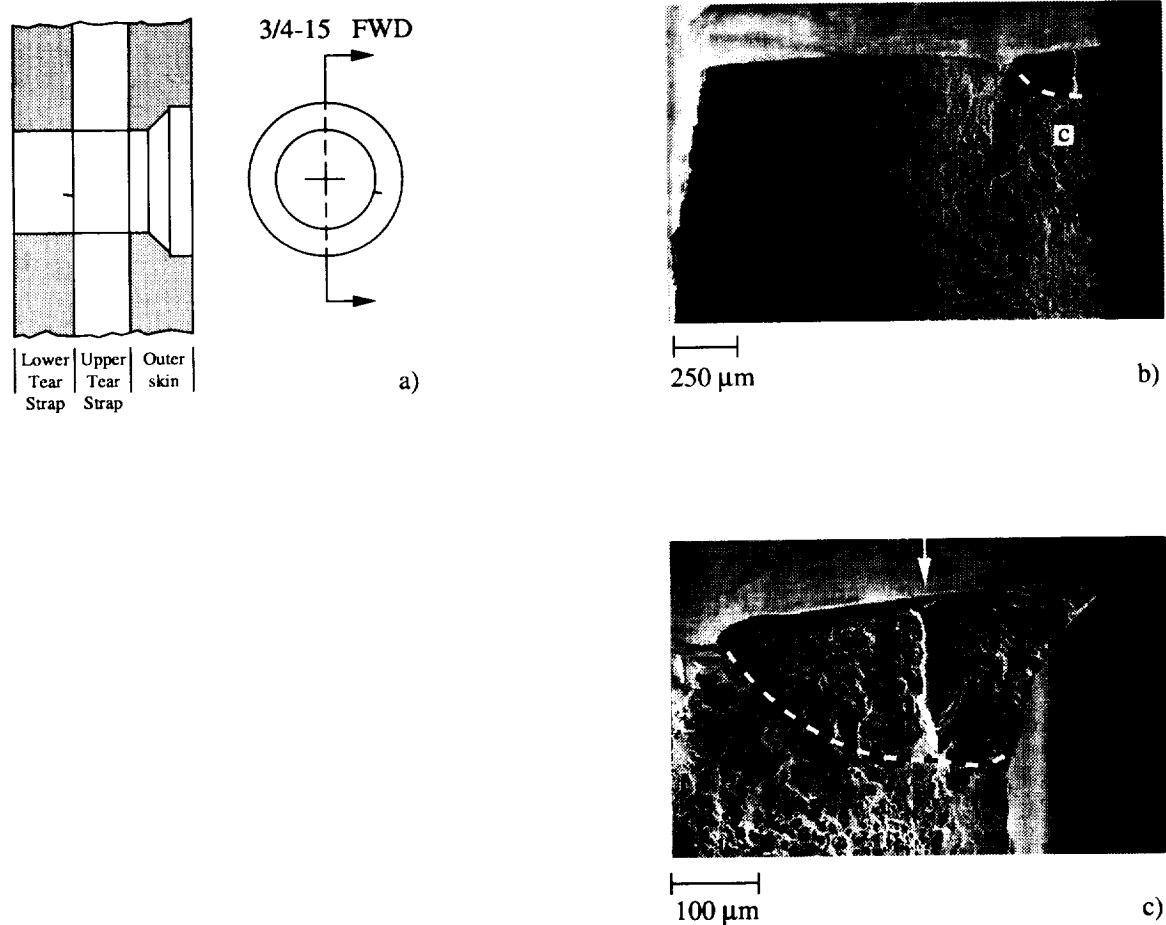
Figure 10.21 a) The schematic shows the rivet hole 3/4-15 configuration and the location of a lower T.S. fatigue crack oriented in the forward direction and about the 3 o'clock position. b) The SEM micrograph shows the fatigue fracture surface of the corner crack located on the outboard corner of the rivet hole. The dashed line marks the fatigue crack front. c) The SEM micrograph shows the fatigue fracture surface of the corner crack (region "c" in Figure 10.21.b). The arrow marks the likely site of crack initiation and the dashed line marks the fatigue crack front.

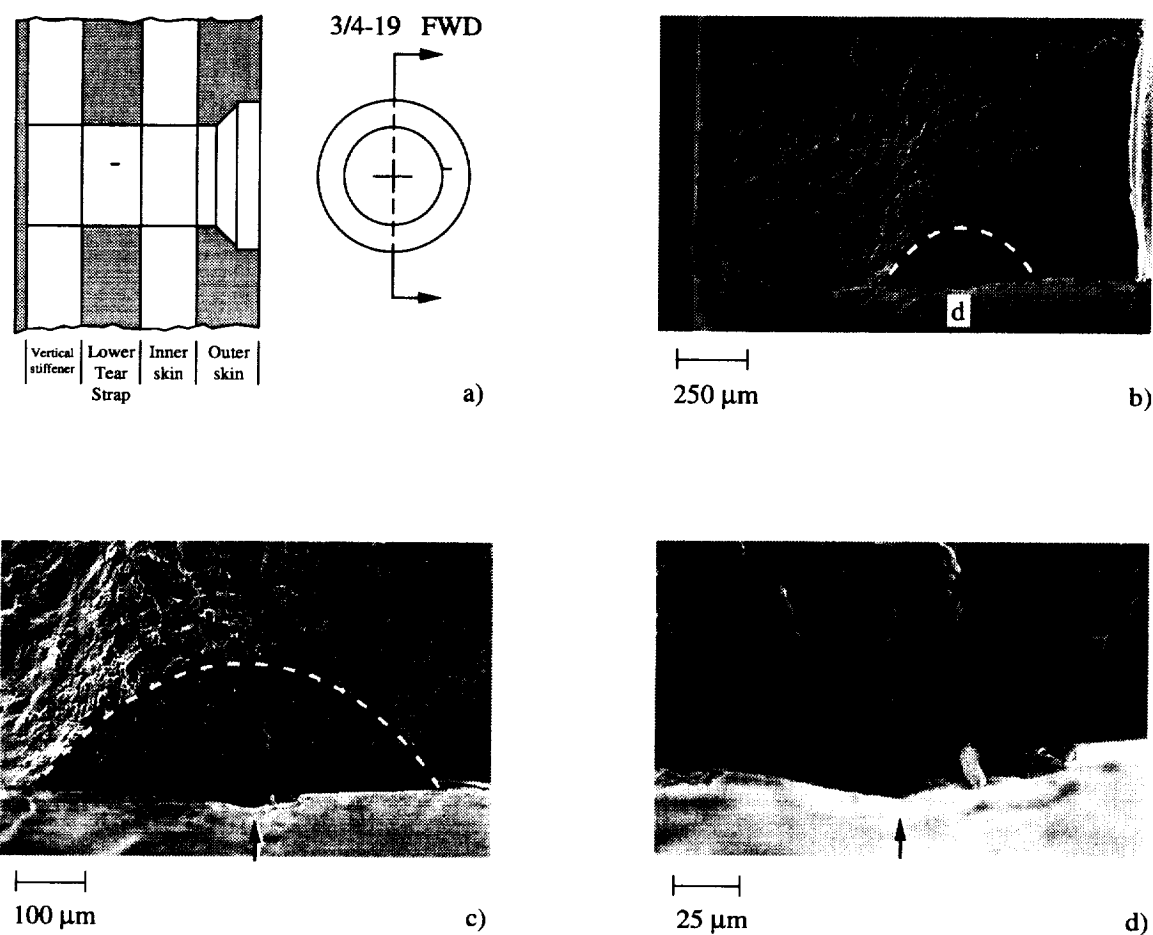
Figure 10.24 a) The schematic shows the rivet hole 3/4-19 configuration and the location of the lower T.S. fatigue crack oriented in the forward direction and above the 3 o'clock position. b) The SEM micrograph shows the fracture surface of the fatigue crack located on the inside surface of the lower T.S. rivet hole. The dashed line marks the fatigue crack front. c) The SEM micrograph shows the surface fatigue crack located at region "d" in Figure 10.34.b. The arrow marks the site of crack initiation and the dashed line marks the fatigue crack front. d) The SEM micrograph shows the crack initiation site (arrow) at high magnification.

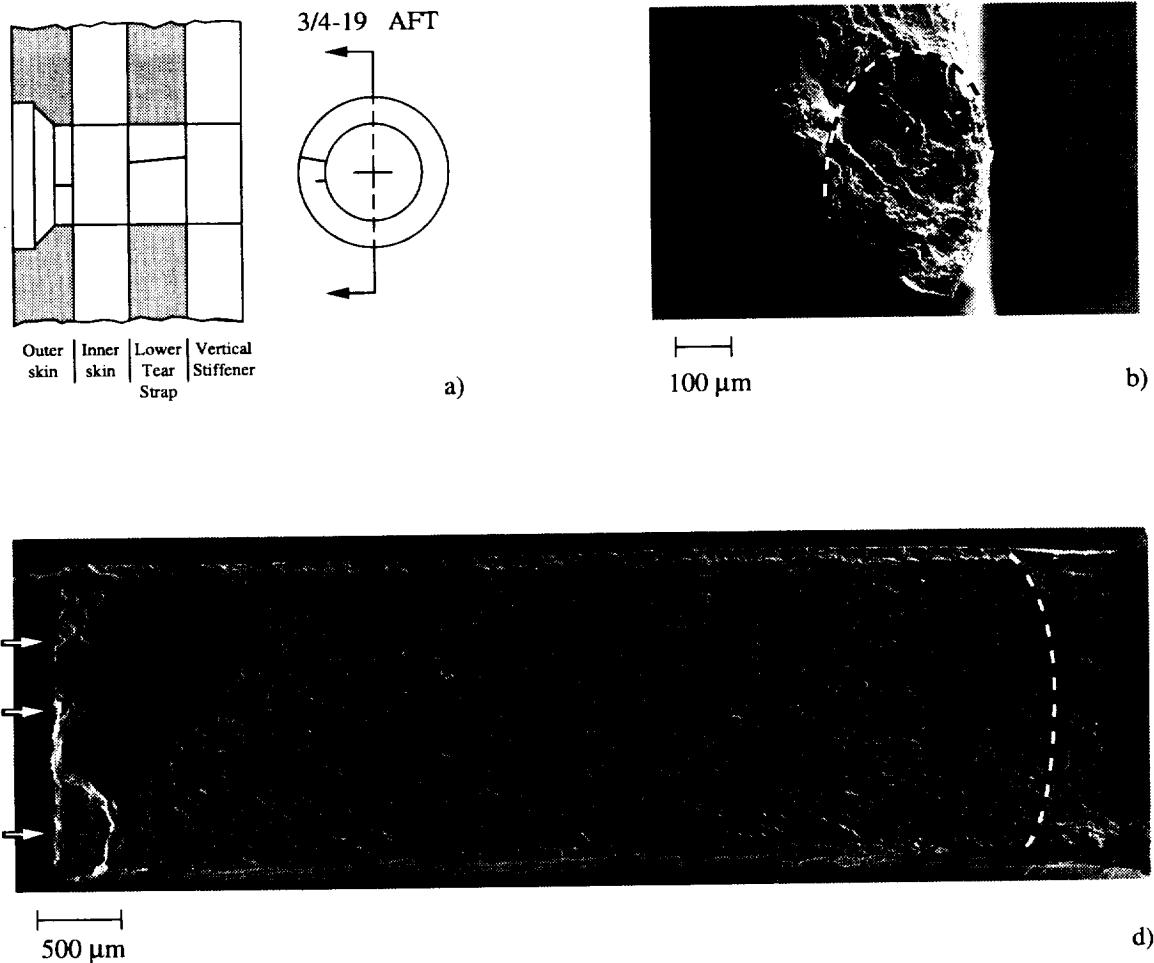
Figure 10.25 a) The schematic shows the rivet hole 3/4-19 configuration and the location of an outer skin fatigue crack and a lower T.S. fatigue crack oriented in the aft direction and about the 3 o'clock position b) The SEM micrograph shows the fracture surface of the fatigue crack located at the shank region of the outer skin rivet hole. The dashed line marks the fatigue crack front. c) The SEM micrograph shows the fracture surface of the lower T.S. fatigue crack. Arrows mark the likely crack initiation sites at the rivet hole surface and the dashed line marks the fatigue crack front.

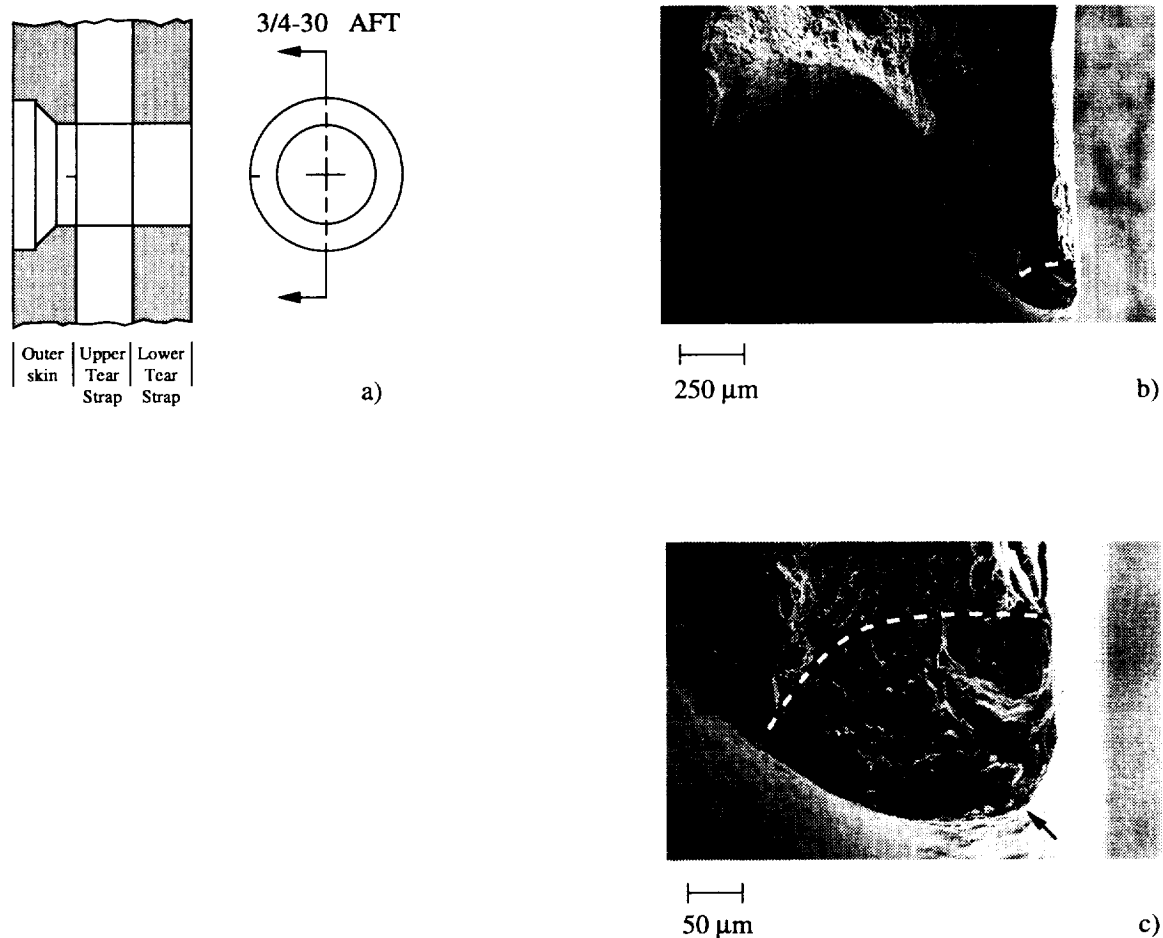
Figure 10.27 a) The schematic shows the rivet hole 3/4-30 configuration and the location of the outer skin fatigue crack oriented in the aft direction and about the 9 o'clock position. b) The SEM micrograph shows the fracture surface of the fatigue crack located at the shank region of the outer skin rivet hole. The dashed line marks the fatigue crack front. c) The SEM micrograph shows the fatigue crack at higher magnification. The arrow marks the likely site of crack initiation and the dashed line marks the fatigue crack front.

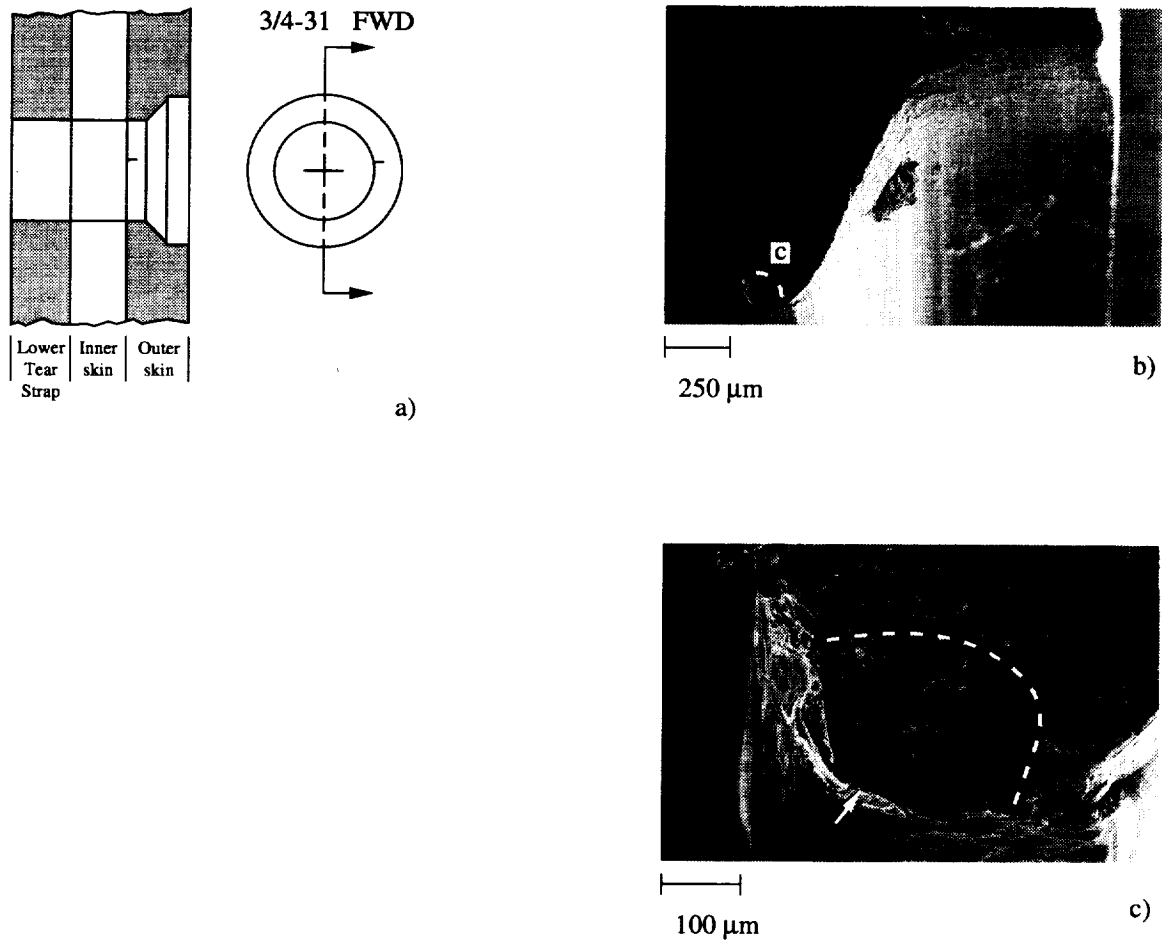
Figure 10.28 a) The schematic shows the rivet hole 3/4-31 configuration and the location of the outer skin fatigue crack oriented in the forward direction and about the 3 o'clock position. b) The SEM micrograph shows the fracture surface of the fatigue crack located at the shank region of the outer skin rivet hole. The dashed line marks the fatigue crack front. c) The SEM micrograph shows the fatigue crack at region "c" in Figure 10.28.b at higher magnification. The arrow marks the likely site of crack initiation and the dashed line marks the fatigue crack front.

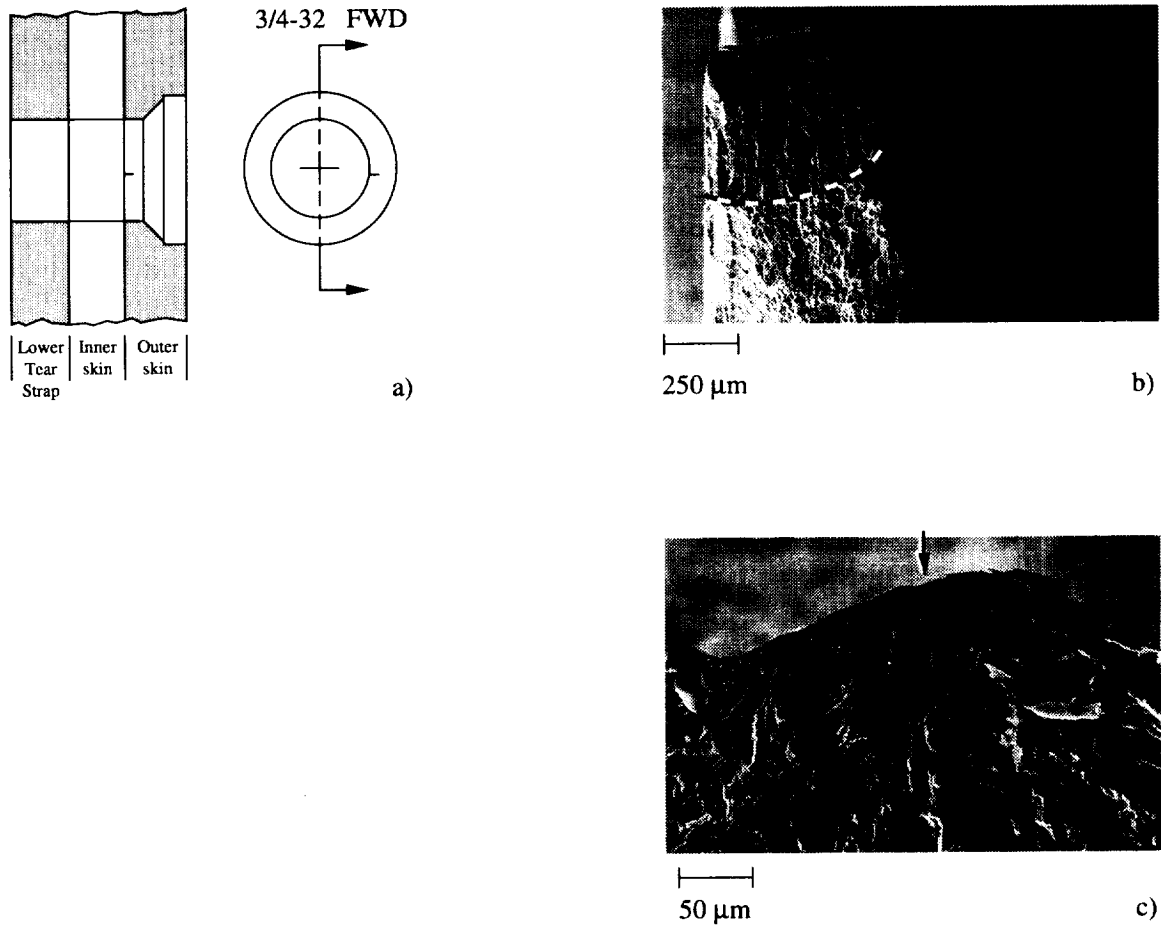
Figure 10.29 a) The schematic shows the rivet hole 3/4-32 configuration and the location of the outer skin fatigue crack oriented in the forward direction and about the 3 o'clock position. b) The SEM micrograph shows the fracture surface of the fatigue crack located at the shank region of the outer skin rivet hole. The dashed line marks the fatigue crack front. c) The SEM micrograph shows the fatigue crack at higher magnification. The arrow marks the likely site of crack initiation.

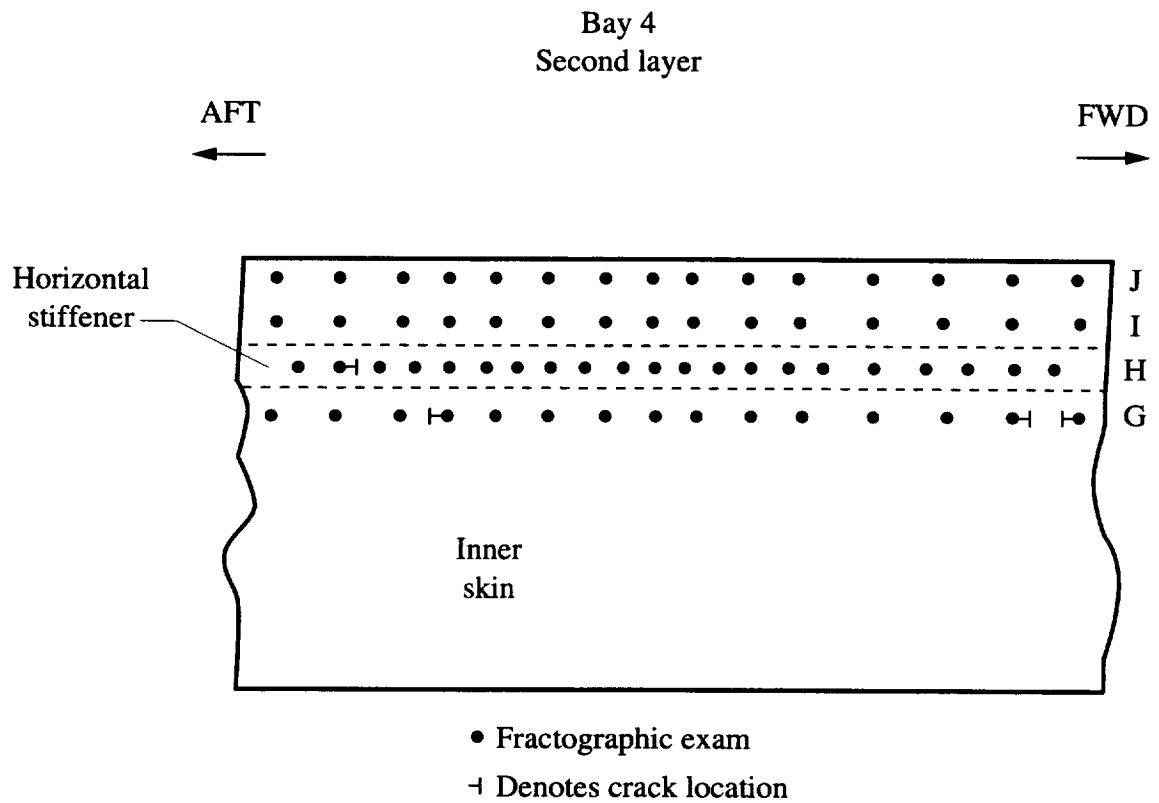
Figure 11.3 The schematic shows the location of fatigue cracks found in the second layer (inner skin) of the bay 4 lap splice joint by destructive examination.

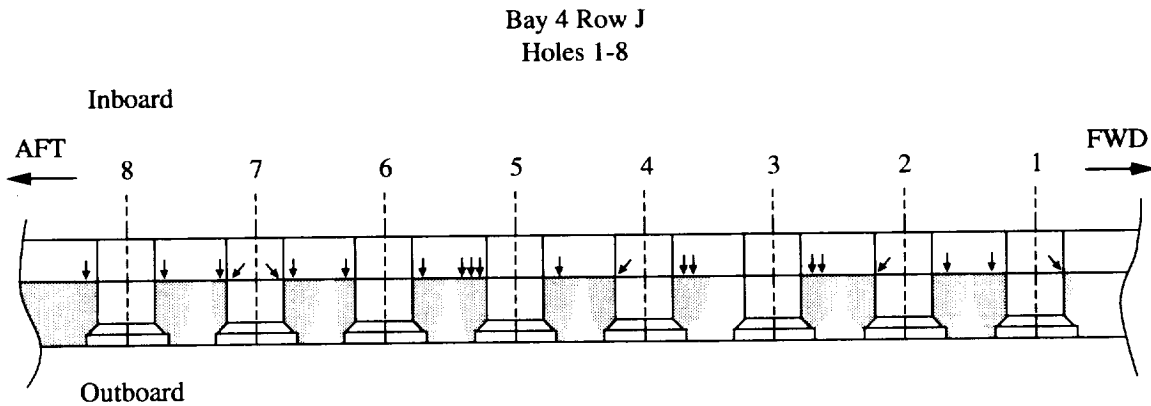
Row J: Fatigue cracks initiated along the outer/inner skin faying surface and the inboard corner of the rivet hole. The faying surface exhibited black oxide and disturbed metal suggesting fretting contact at the point of crack initiation.

Row J: A distinct pattern in crack front shape was observed. Cracks initiated at the faying surface and grew subsurface to the outboard surface. The subsurface fatigue cracks formed a thin ligament along the outboard surface of the outer skin. The fatigue cracks propagated along the faying surface a distance of 2 to 3 skin thicknesses before becoming through-thickness cracks.

Hole #	Location	Length mm(in)	Type	Initiation site
1 (Aft)	Outer skin	2.893 (0.114)	Fretting	Inner skin/Outer skin
1 (Fwd)	Outer skin	0.769 (0.030)	Fretting	IS/OS
2 (Aft)	Outer skin	0.905 (0.036)	Fretting	IS/OS
2 (Fwd)	Outer skin	2.814 (0.111)	Fretting	IS/OS
3 (Fwd)	Outer skin	2.427 (0.096)	Fretting	IS/OS multiple
4 (Aft)	Outer skin	2.497 (0.098)	Fretting	IS/OS
4 (Fwd)	Outer skin	2.700 (0.106)	Fretting	IS/OS
5 (Aft)	Outer skin	5.334 (0.210)	Fretting	IS/OS multiple
5 (Fwd)	Outer skin	5.279 (0.207)	Fretting	IS/OS
6 (Aft)	Outer skin	2.714 (0.107)	Fretting	IS/OS
6 (Fwd)	Outer skin	3.848 (0.152)	Fretting	IS/OS
7 (Aft)	Outer skin	1.113 (0.044)	Fretting	IS/OS, inboard corner
7 (Fwd)	Outer skin	3.310 (0.130)	Fretting	IS/OS, inboard corner
8 (Aft)	Outer skin	Linkup with 4J9 (Fwd)	Fretting	IS/OS
8 (Fwd)	Outer skin	12.954 (0.510)	Fretting	IS/OS

Figure 11.4 The through thickness schematic shows the location and initiation site of fatigue cracks found in rivet row J (holes 1-8) from bay 4. The table summarizes crack location, crack length, crack type, and initiation site for each fatigue crack shown.

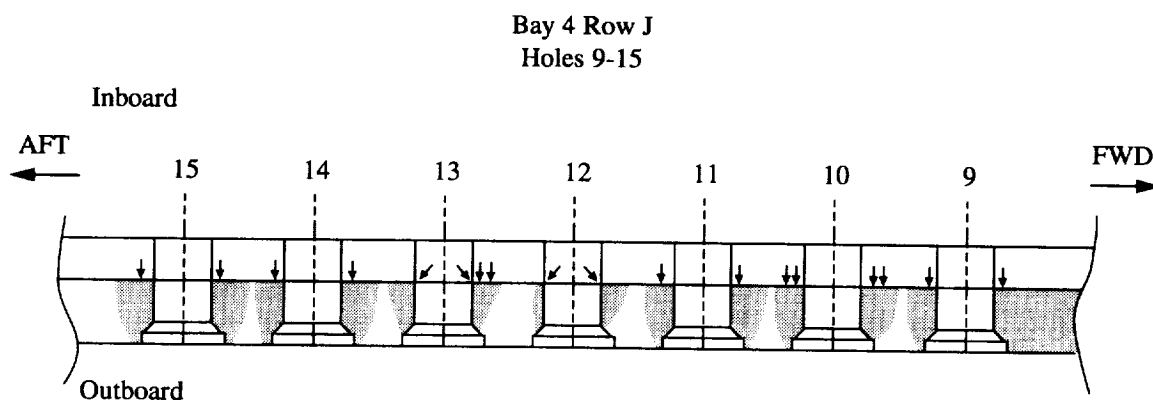
Hole #	Location	Length mm(in)	Type	Initiation site
9 (Aft)	Outer skin	8.265 (0.325)	Fretting	Inner skin/Outer skin
9 (Fwd)	Outer skin	Linkup with 4J8(Aft)	Fretting	IS/OS
10 (Aft)	Outer skin	4.194 (0.165)	Fretting	IS/OS multiple
10 (Fwd)	Outer skin	3.042 (0.120)	Fretting	IS/OS multiple
11 (Aft)	Outer skin	5.397 (0.212)	Fretting	IS/OS
11 (Fwd)	Outer skin	5.675 (0.223)	Fretting	IS/OS
12 (Aft)	Outer skin	1.874 (0.074)	Countersink	Inboard corner of shank
12 (Fwd)	Outer skin	2.460 (0.097)	Countersink	Inboard corner of shank
13 (Aft)	Outer skin	1.835 (0.072)	Countersink	Inboard corner of shank
13 (Fwd)	Outer skin	1.102 (0.043)	Fretting	IC,IS/OS multiple
14 (Aft)	Outer skin	2.995 (0.118)	Fretting	IS/OS multiple
14 (Fwd)	Outer skin	2.810 (0.111)	Fretting	IS/OS
15 (Aft)	Outer skin	8.559 (0.337)	Fretting	IS/OS
15 (Fwd)	Outer skin	6.959 (0.274)	Fretting	IS/OS

Figure 11.5 The through thickness schematic shows the location and initiation site of fatigue cracks found in rivet row J (holes 9-15) from bay 4. The table summarizes crack location, crack length, crack type, and initiation site for each fatigue crack shown.

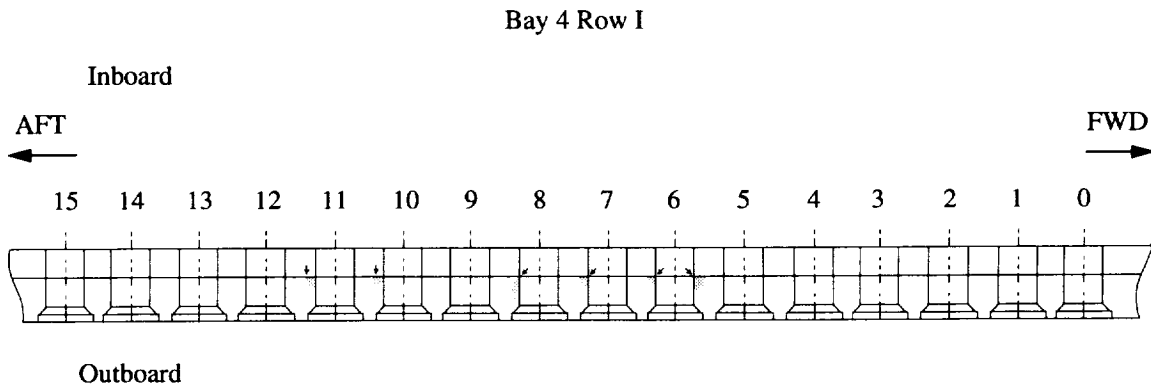
Row I: Most outer skin fatigue cracks initiated at the inboard corner rivet hole shank region and along the faying surface. Cracks initiated at deformed regions and regions having disturbed surfaces.

Hole #	Location	Length mm(in)	Type	Initiation site
6(Aft)	Outer skin	0.116 (0.005)	Countersink	Inboard corner of shank
6(Fwd)	Outer skin	0.285 (0.011)	Countersink	Inboard corner of shank
7(Aft)	Outer skin	0.105 (0.004)	Countersink	Inboard corner of shank
8(Aft)	Outer skin	0.199 (0.008)	Countersink	Inboard corner of shank
10(Aft)	Outer skin	0.089 (0.003)	Fretting	IS/OS
11(Aft)	Outer skin	0.039 (0.002)	Fretting	IS/OS

Figure 11.6 The through thickness schematic shows the location and initiation site of fatigue cracks found in rivet row I from bay 4. The table summarizes crack location, crack length, crack type, and initiation site for each fatigue crack shown.

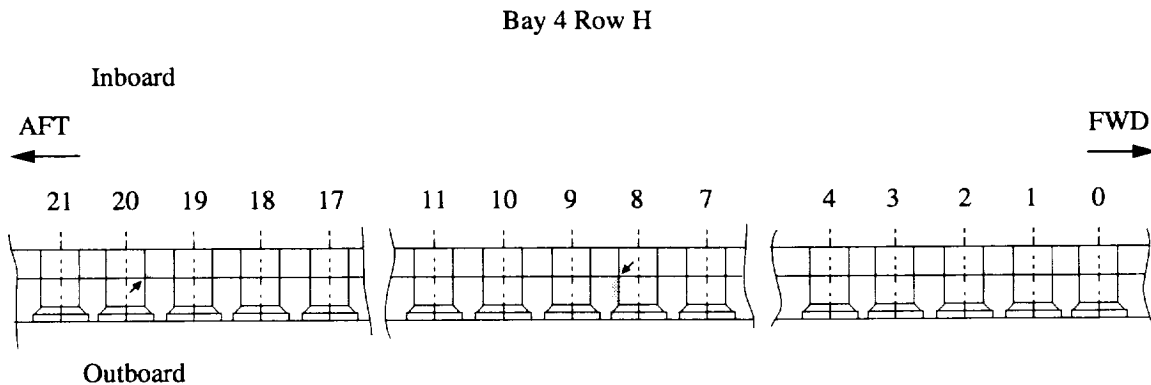
Hole #	Location	Length mm(in)	Type	Initiation site
8(Aft)	Outer skin	0.102 (0.004)	Countersink	Inboard corner of shank
20(Fwd)	Inner skin	0.237 (0.009)	Corner	Outboard corner

Figure 11.7 The through thickness schematic shows the location and initiation site of fatigue cracks found in rivet row H from bay 4. The table summarizes crack location, crack length, crack type, and initiation site for each fatigue crack shown.

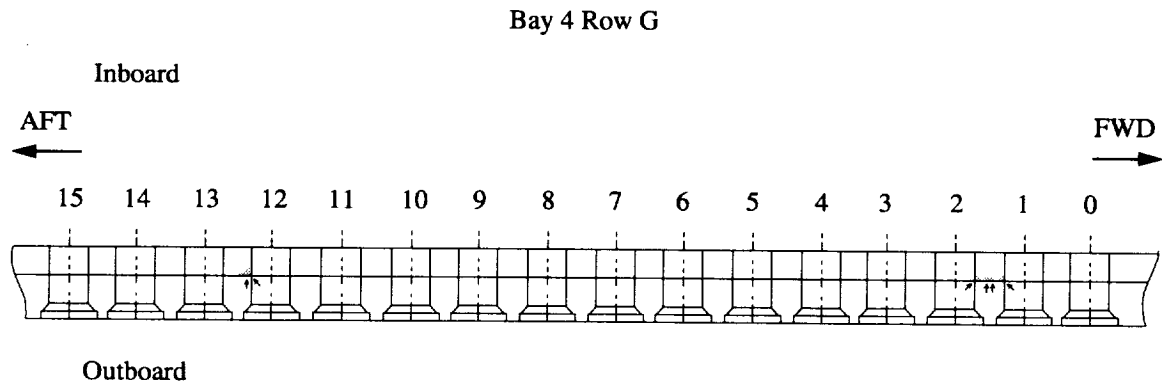
Row H and G: Fatigue cracks initiated at outboard corners of inner skin rivet holes. Areas of disturbed metal were observed at the point of crack initiation. A few outer skin fatigue cracks were noted at the rivet hole faying surface, similar to those found in row J.

Hole #	Location	Length mm(in)	Type	Initiation site
1(Aft)	Inner skin	0.121 (0.005)	Corner	Outboard corner
2(Fwd)	Inner skin	0.131 (0.005)	Fretting and Corner	IS/OS, Outboard corner
2(Fwd)	Inner skin	0.180 (0.007)	Fretting	Innerskin/outerskin
12(Aft)	Inner skin	0.313 (0.012)	Fretting and Corner	IS/OS, Outboard corner

Figure 11.8 The through thickness schematic shows the location and initiation site of fatigue cracks found in rivet row G from bay 4. The table summarizes crack location, crack length, crack type, and initiation site for each fatigue crack shown.

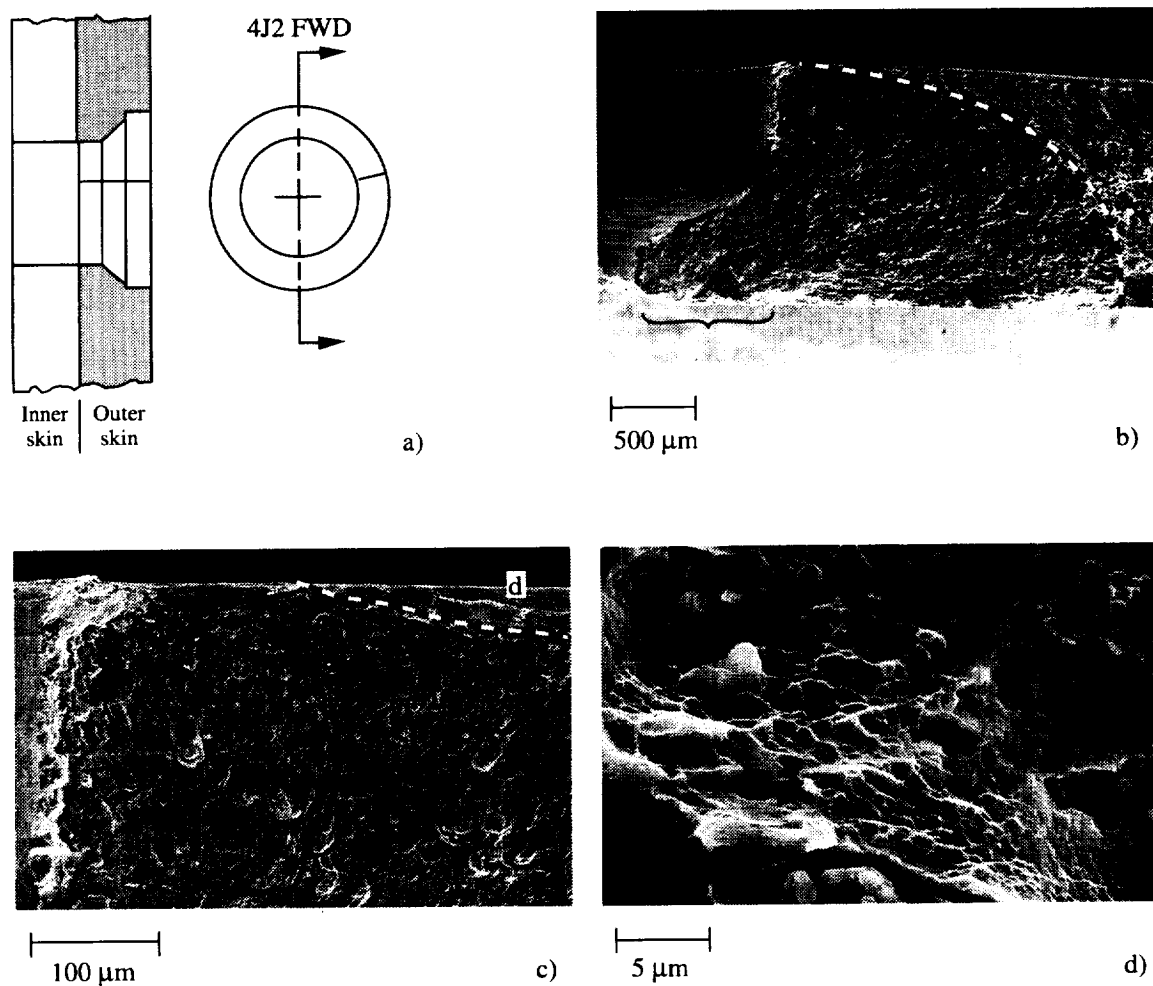
Figure 11.12 a) The schematic shows the rivet hole 4J2 configuration and the location of the outer skin fatigue crack oriented in the aft direction and about the 10 o'clock position. b) The SEM micrograph shows the fatigue crack fracture surface located at the outer skin rivet hole (bottom). The arrow marks the likely crack initiation site and the dashed line marks the fatigue crack front. c) The SEM micrograph shows the fatigue crack front region "c" in Figure 11.12.b. The arrow marks the region of crack initiation.

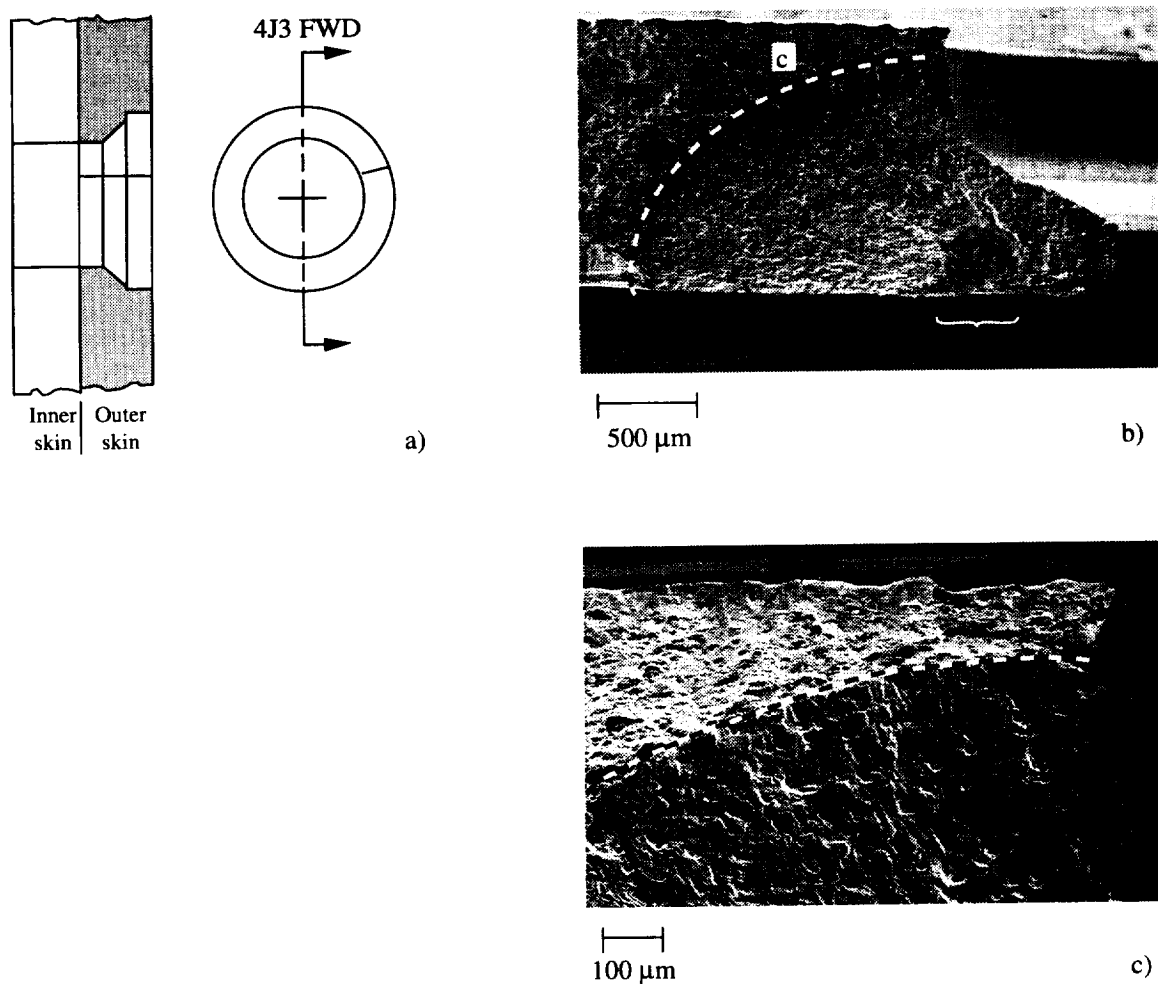
Figure 11.13 a) The schematic shows the rivet hole 4J3 configuration and the location of the outer skin fatigue crack oriented in the forward direction and about the 2 o'clock position. b) The SEM micrograph shows the fatigue crack fracture surface located at the outer skin rivet hole (right). The dashed line marks the fatigue crack front and the bracket marks the region of crack initiation. c) The SEM micrograph shows the fatigue crack front and the ligament, region "c", in Figure 11.13.b. The dashed line marks the fatigue crack front where it intersects the rivet hole (right). The outboard surface of the outer skin is located at the top of the micrograph.
